**Montana Fish,
Wildlife & Parks**

Ravalli County Stream Setbacks

The following photographs illustrate a variety of situations along streams in Ravalli County. The gray rectangles in some of the photos are intended to disguise individual homes. Homes in these pictures vary from new to those established many years ago. Pages 1-10 illustrate recent situations often involving streamchannel changes. The situations on pages 11-17 are not from situations as recent as the previous pictures, but they illustrate issues associated with development near streams. Homes that were built many years ago, that have recently had problems, illustrate that streams do change over time and building more homes near streams will only add to these problems.

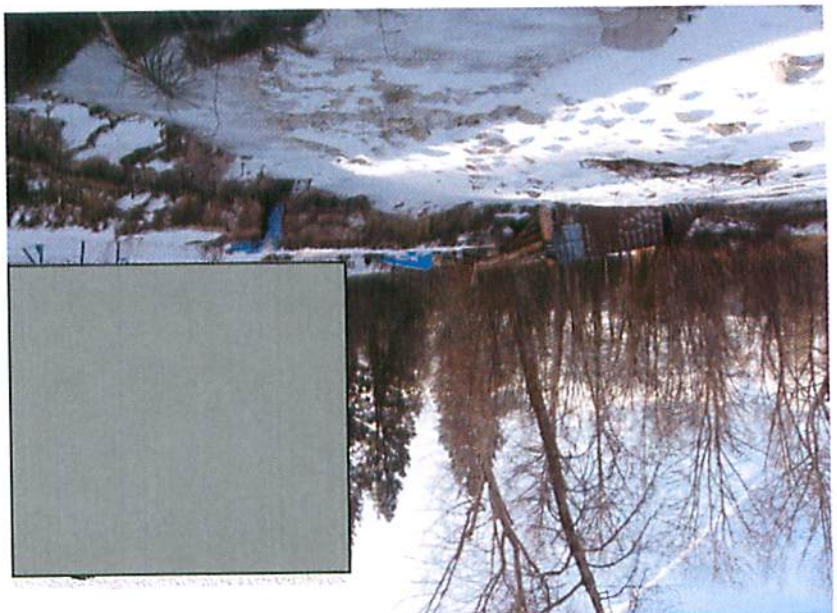
Fred Burr Creek (2007) – lateral stream migration nearly undercuts home (shed fell in). Homeowner issued permit for significant project to move creek away from home.

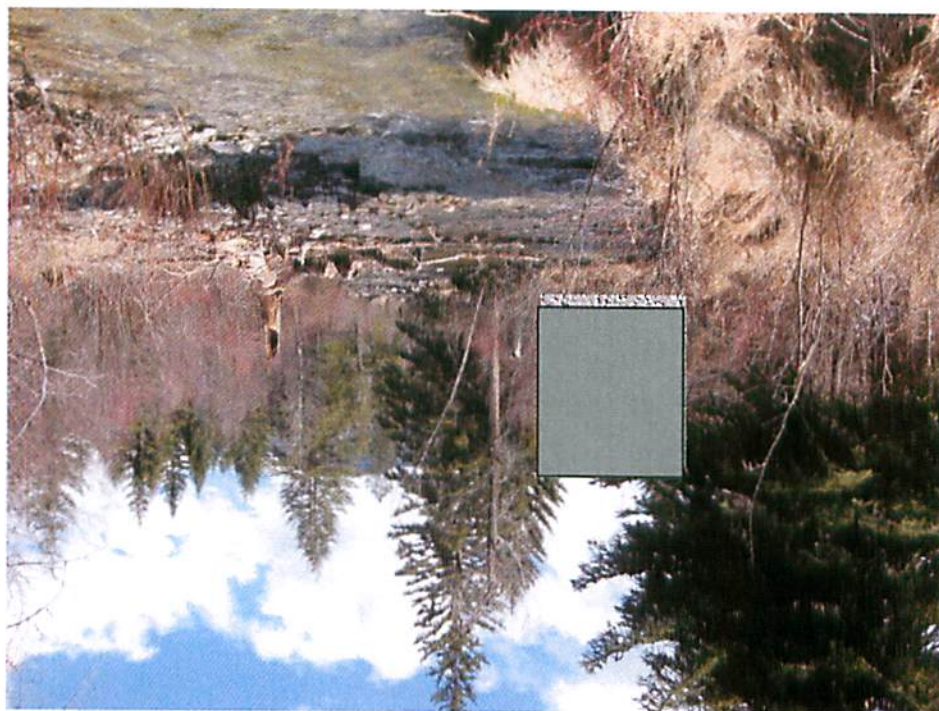
Bear Creek – Note the roof of the new house construction in center left of picture. Picture taken from property of downstream landowner. Have not been onsite of the home, but it is close to the creek.

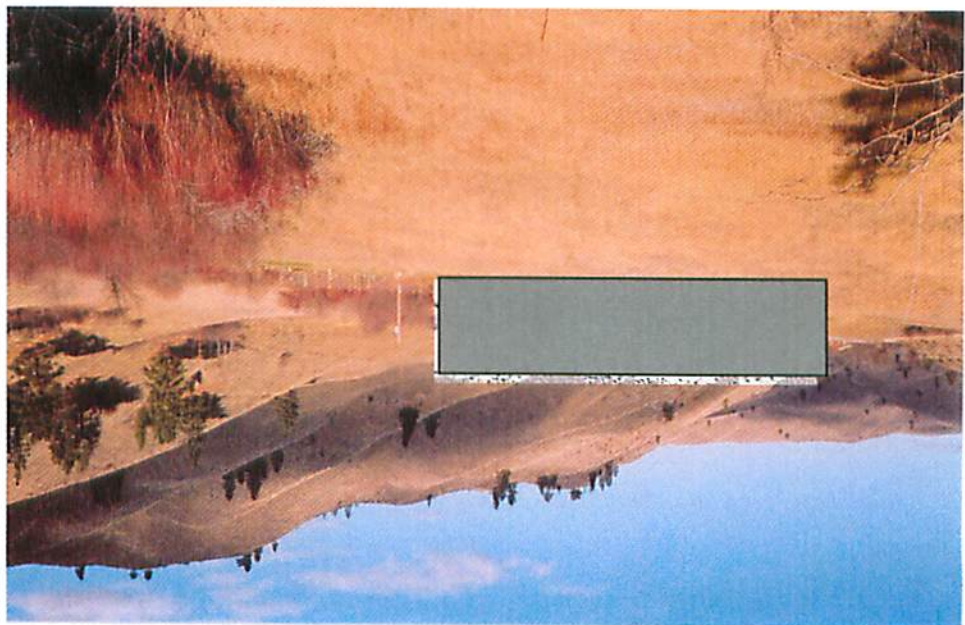
Little Sleeping Creek (2005 photo)– Home away from creek but development close to creek.

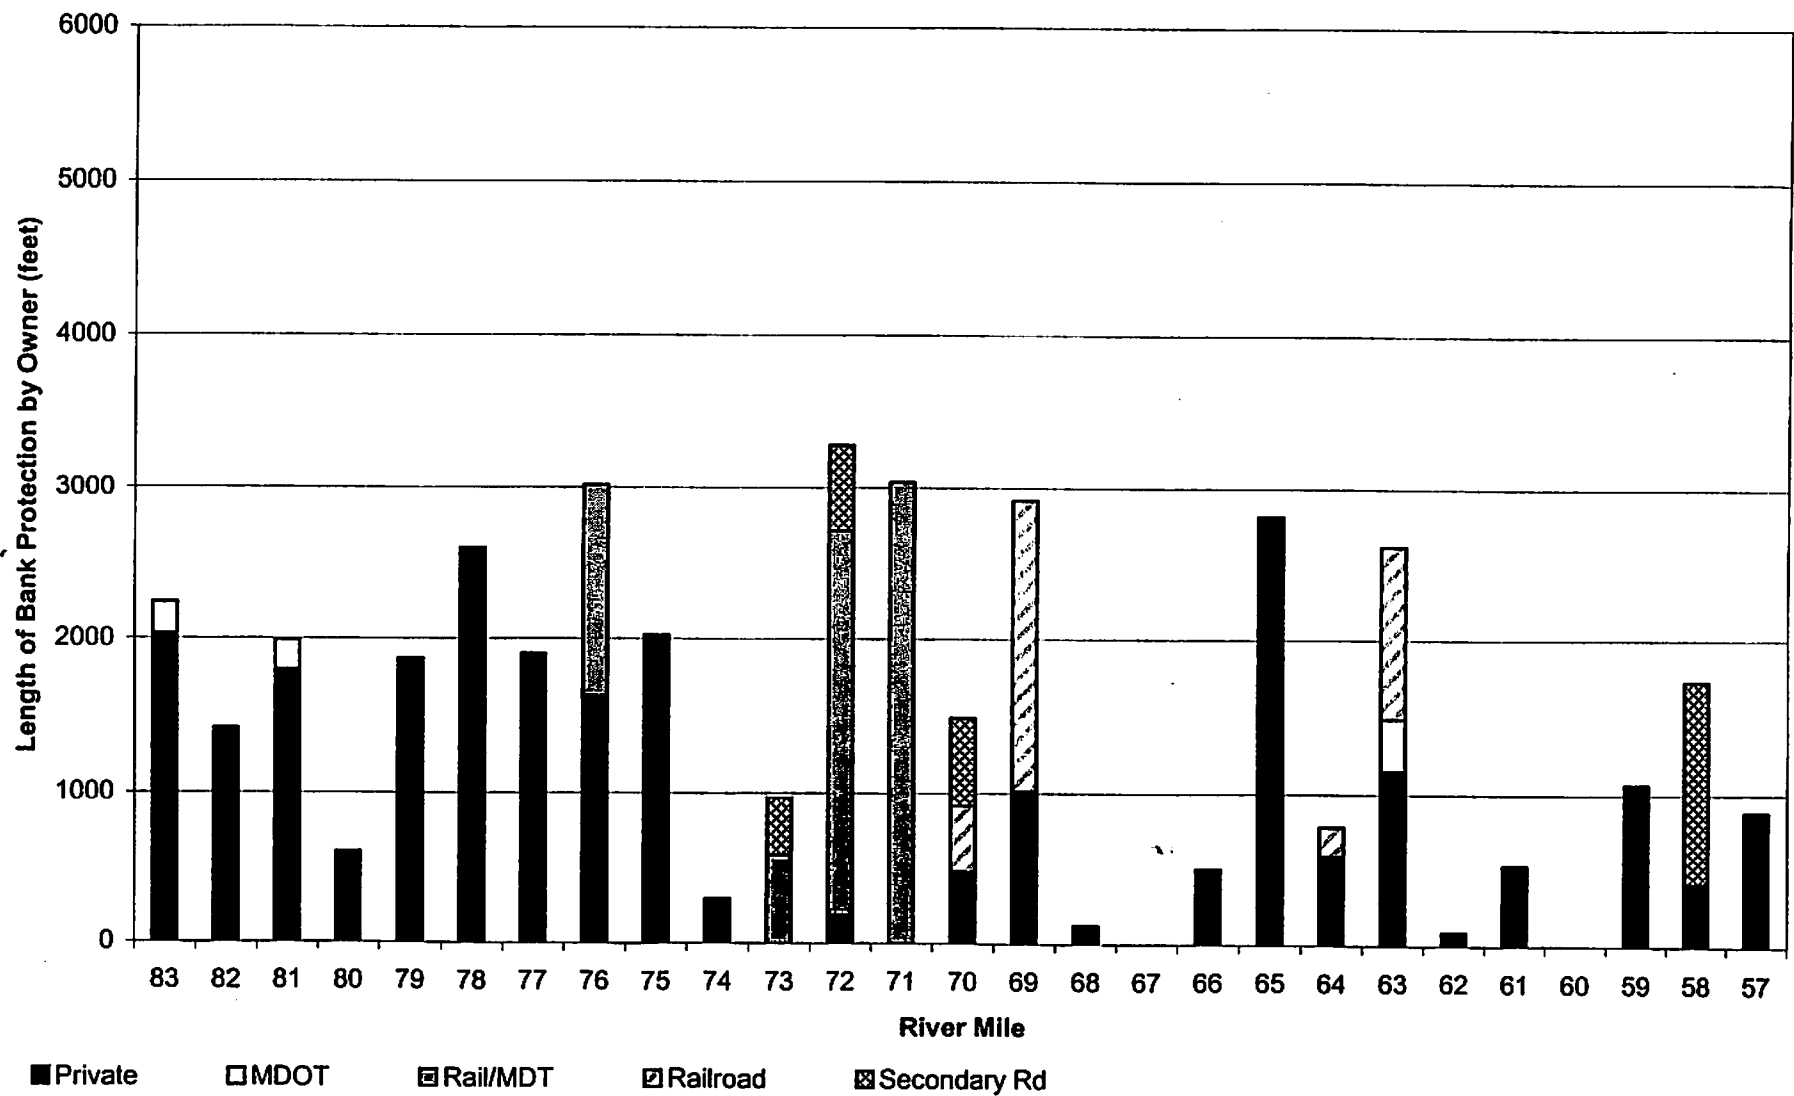
Figure 4A. Total inventory and relative distribution of bank protection along the main stem of the Bitterroot River, categorized by responsible party.

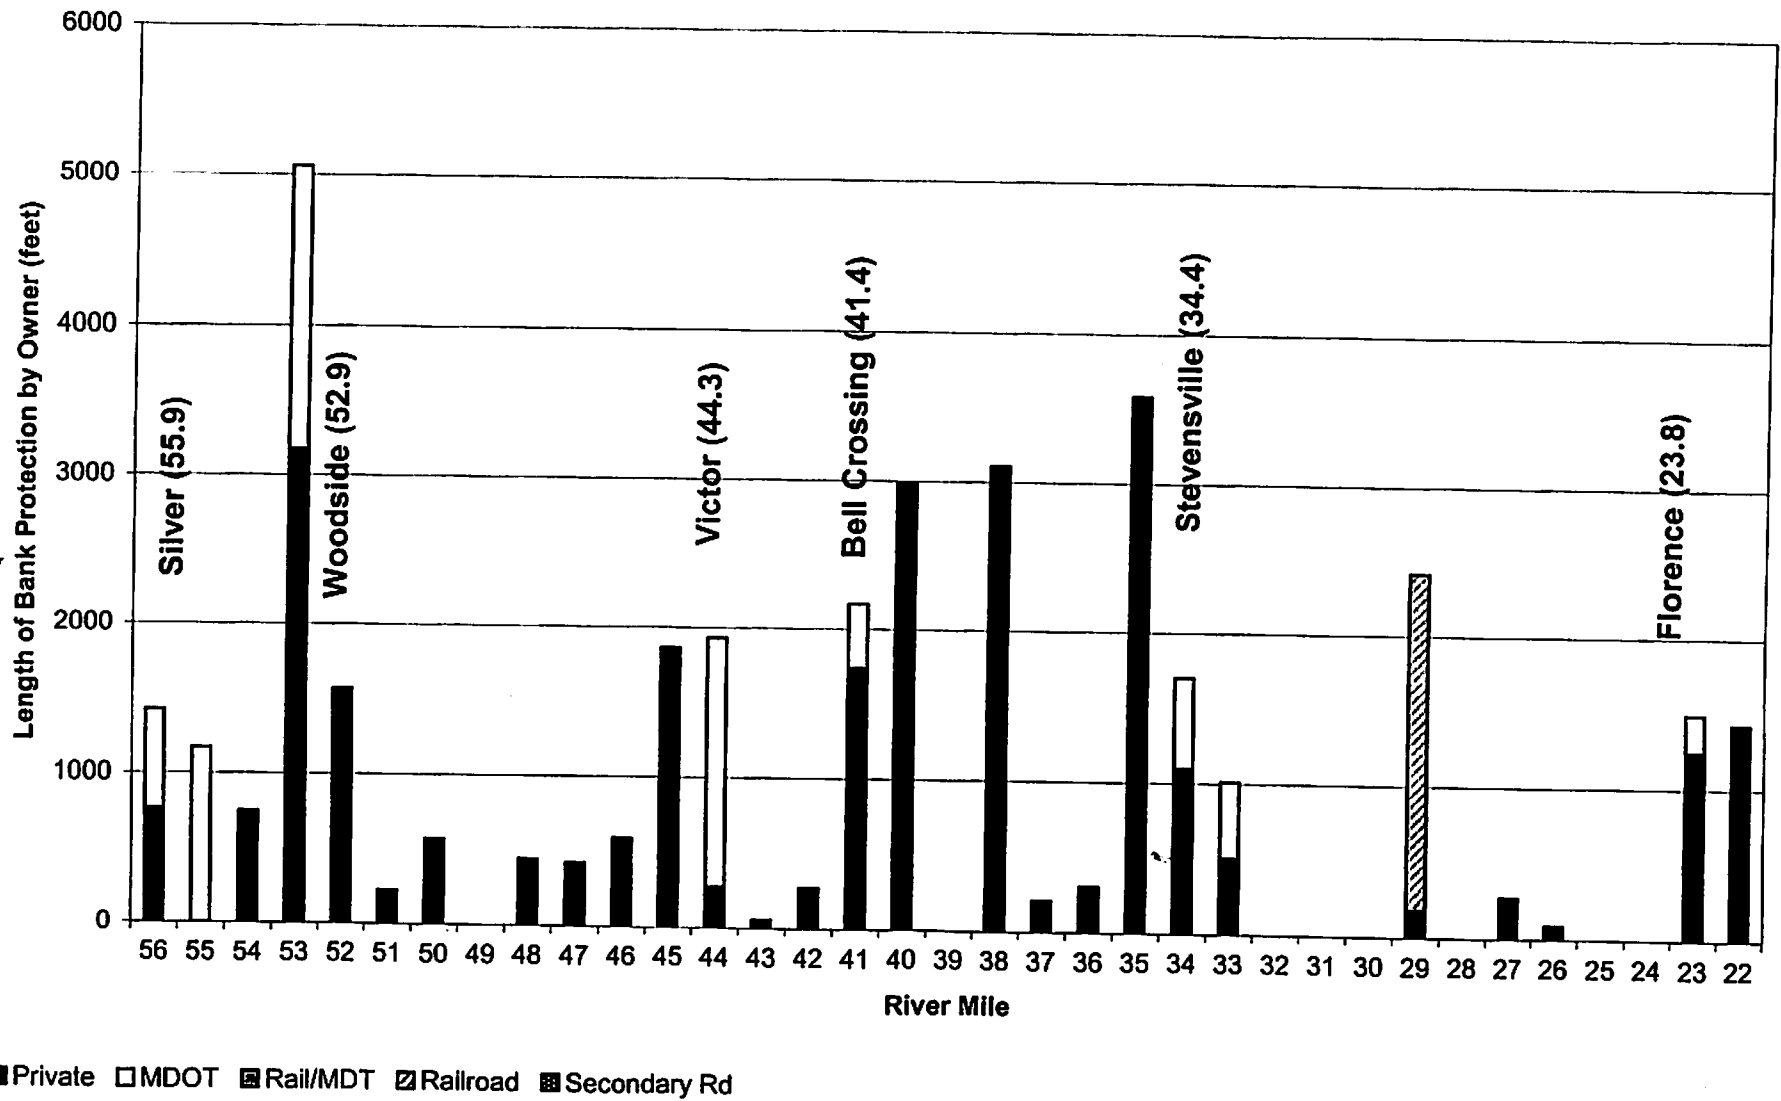
Figure 4B. Total inventory and relative distribution of bank protection along the main stem of the Bitterroot River, categorized by responsible party.
